October 19, 2022

Subject: H2 DesignBuild LLC; Assessment of Heritage Trees  
**CONFIDENTIAL: DO NOT DISTRIBUTE**

H2 DesignBuild LLC; Assessment of Heritage Trees

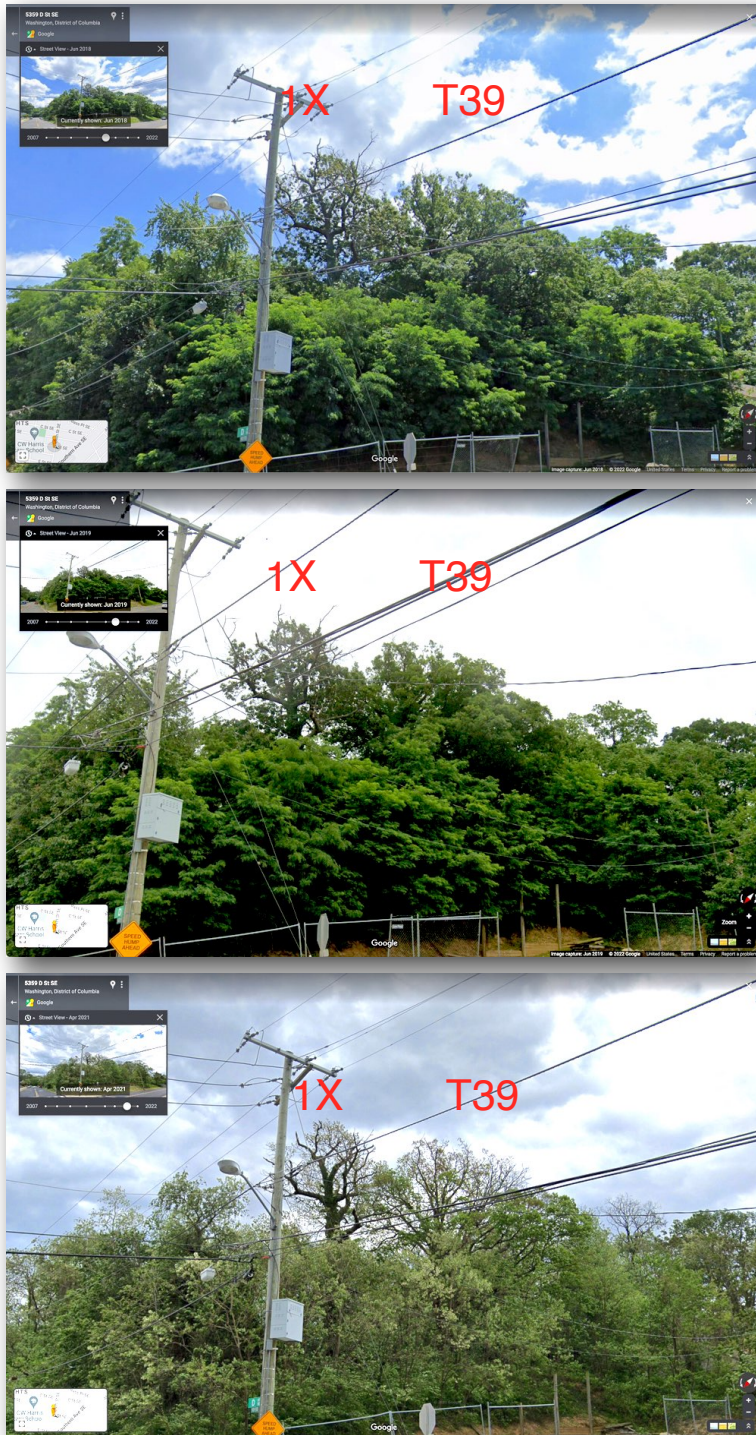
Figures 1, 2, and 3: These images were captured by Google Street View cameras, in June 2018, June 2019, and April 2021, respectively. The images were taken from the west side of the intersection at D Street and 54th Street. The tree on the left is marked as 1X for reference only in this report. Tree 1X was in decline for many years, with large dead branches seen in these images. Aerial images dating to 2012 show dead branches in that tree.

As early as June 2018 (Fig. 1) decline can be seen in the top of T39. There are a few dead branches and thinning of foliage in the upper crown. In Figure 2, June 2019, the thinning appears to be increasing and spreading lower into the crown. By April 2021, the entire crown is involved and in decline.

These images show that the early stages of decline were apparent long before the time of any herbicide application is claimed.

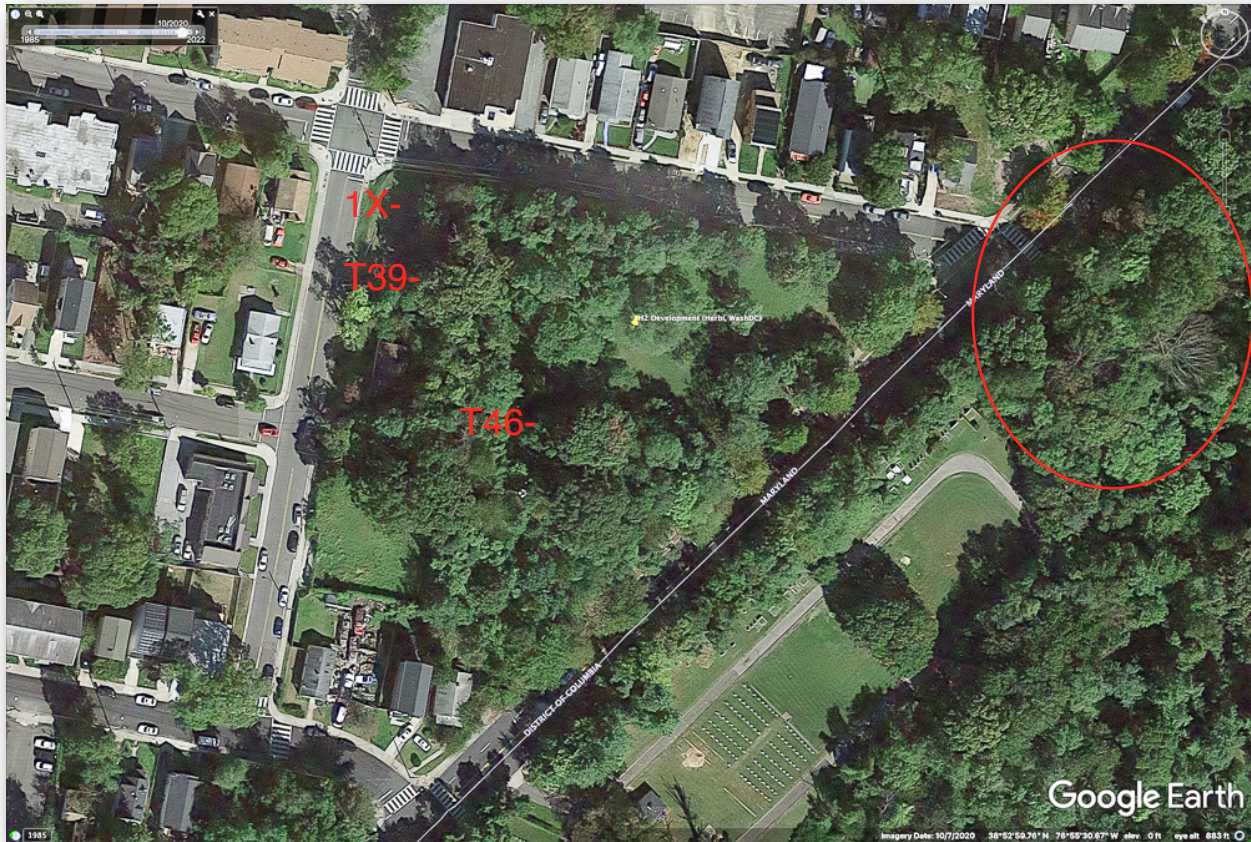
Figure 4: This aerial view was captured in October 2020. Tree T39 can be seen with signs of decline in the upper crown. Tree T46, the other white oak listed in the UFD report, is showing a large dead limb on the east side of the crown. This is before any suggestion of hole-drilling or herbicide treatment. The pattern of decline and limb death is also not consistent with any herbicide treatment to the base or roots of the tree, as that would produce widespread symptoms of decline. A root infection that is invading quickly, such as a virulent attack by *Armillaria*, could produce a local response in the crown such as seen here.

Also note that other trees across Southern Avenue SE are declining or dead (red ellipse). To find a few large old trees in decline is not unusual.
